HETA 93-0531-2410
MARCH 1994
NATIONAL RAILROAD PASSENGER CORPORATION
CHICAGO, ILLINOIS

I. SUMMARY

KEYWORDS: SIC 4011 (Railroads, Line Haul Operating); Ergonomics, Musculoskeletal Injuries, Train Attendants, Superliner® beds.

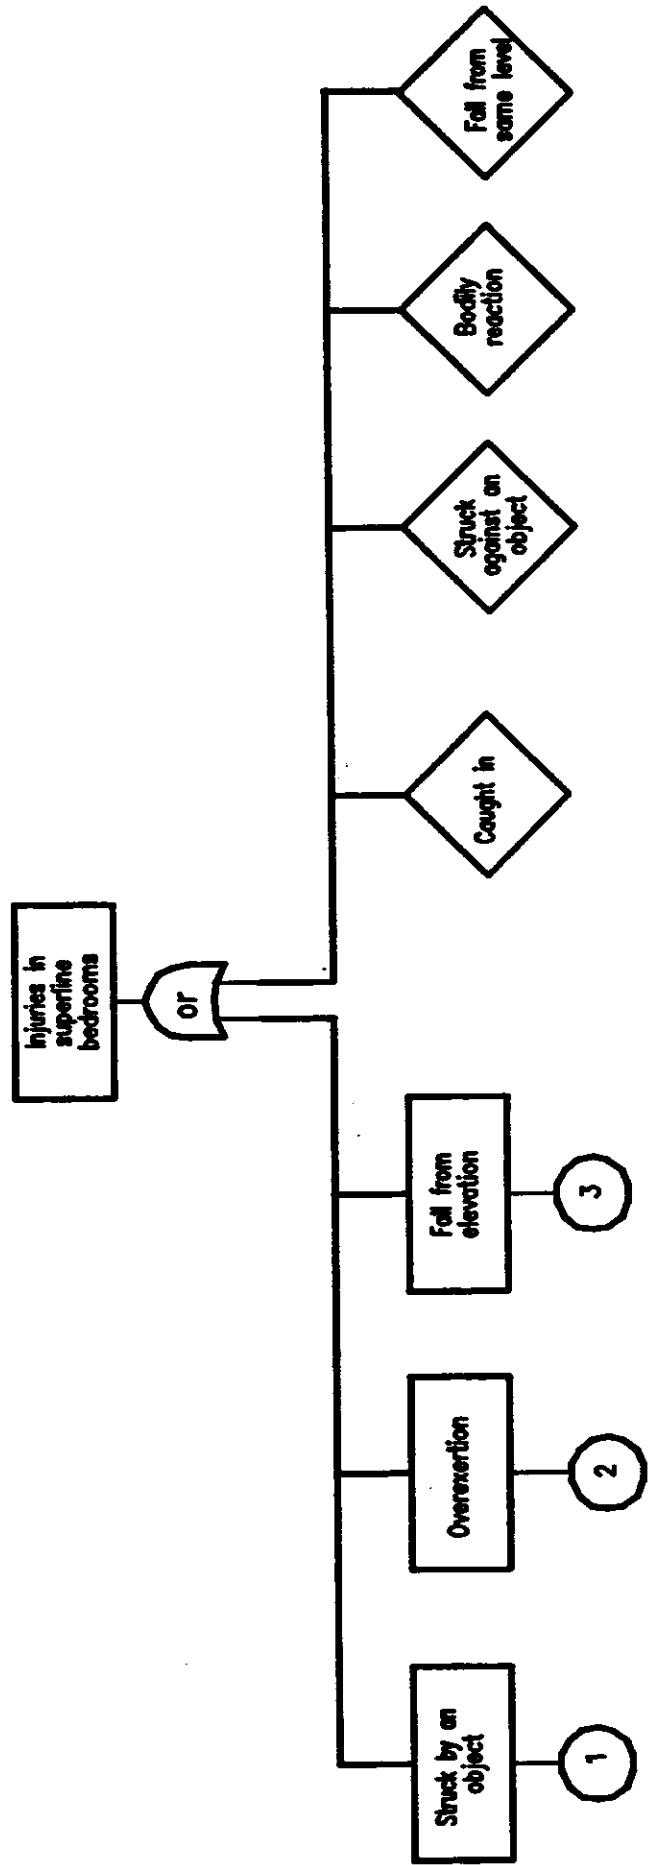
FIGURE 1 - Fault Tree Analysis for Injuries in Superliner® Bedrooms

The train inspections and the review of the injury records revealed that being struck by an object, fall from elevation, and overexertion are the top three injury types in superliner bedrooms. These three categories were analyzed with the fault tree analysis technique and are discussed below and presented in Figures

1-4. Figure 1 presents an overview of the types of injuries seen in Superliner® bedrooms, three of which are further analyzed in Figures 2-4.

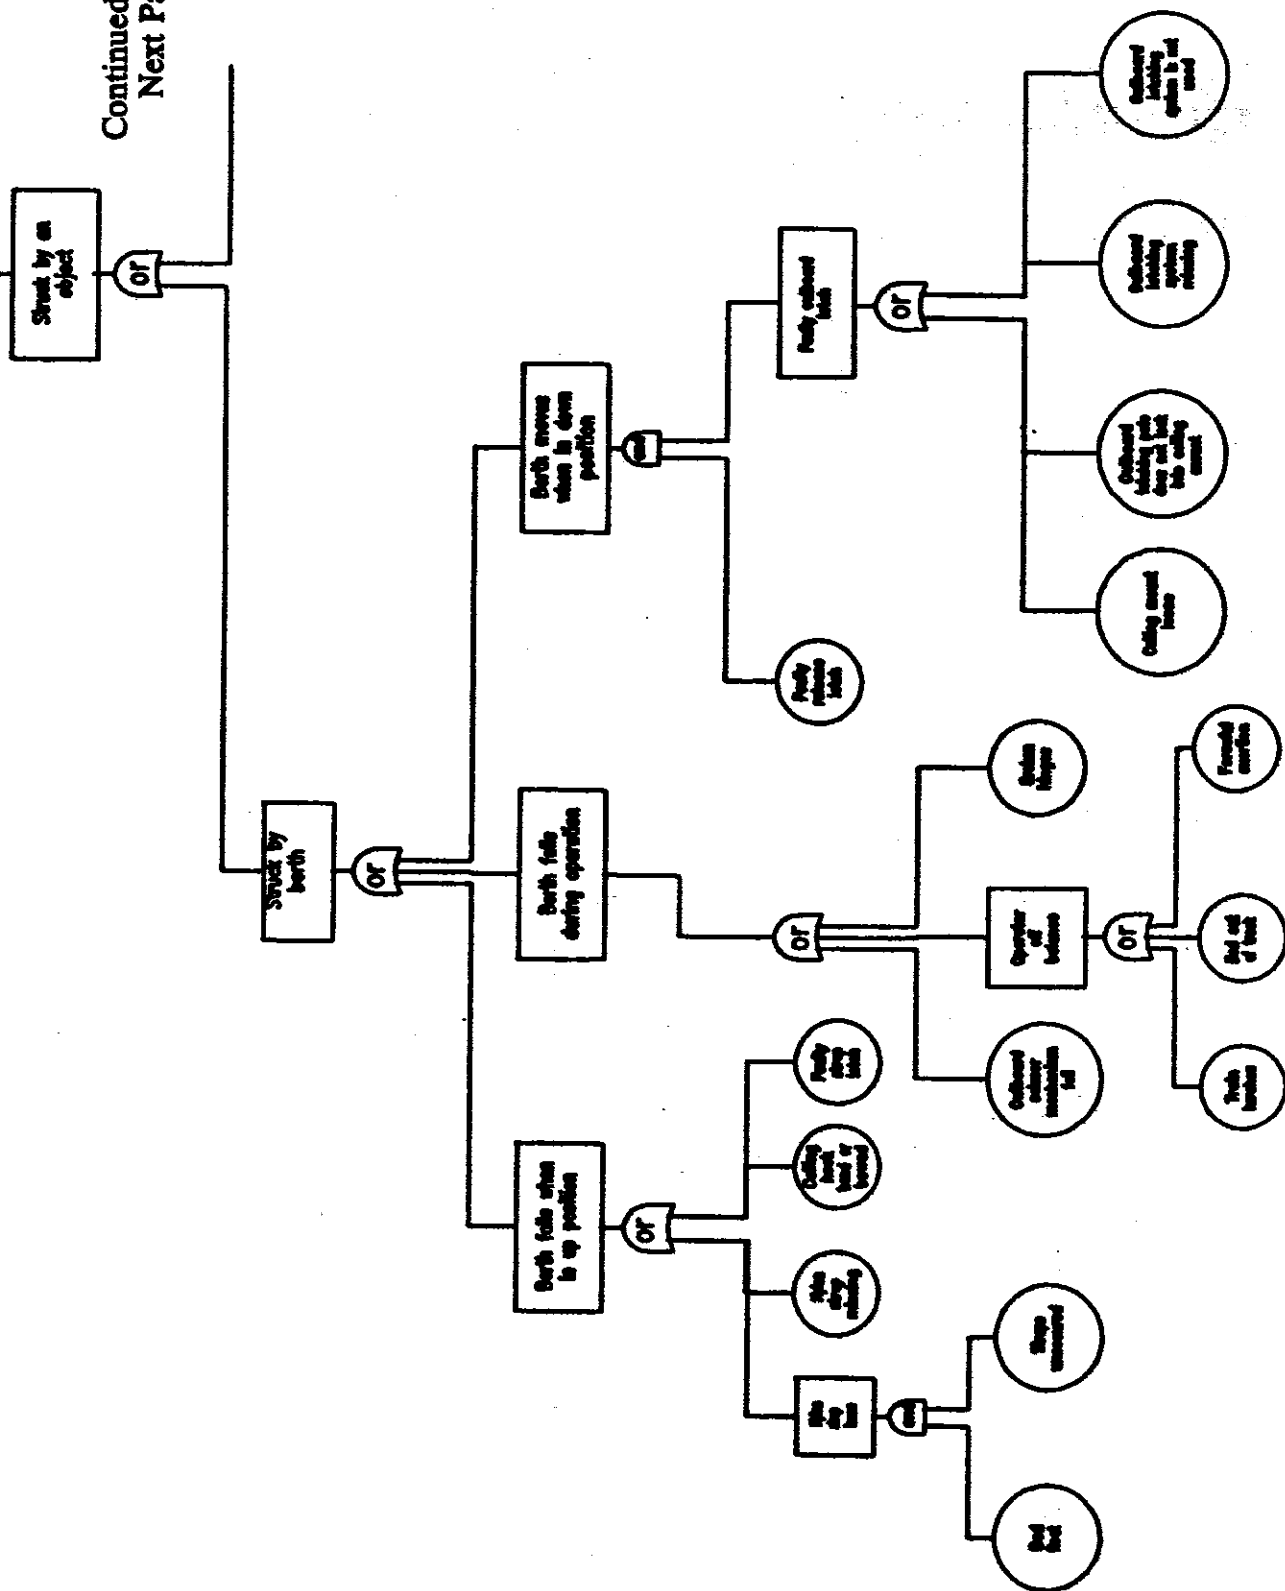
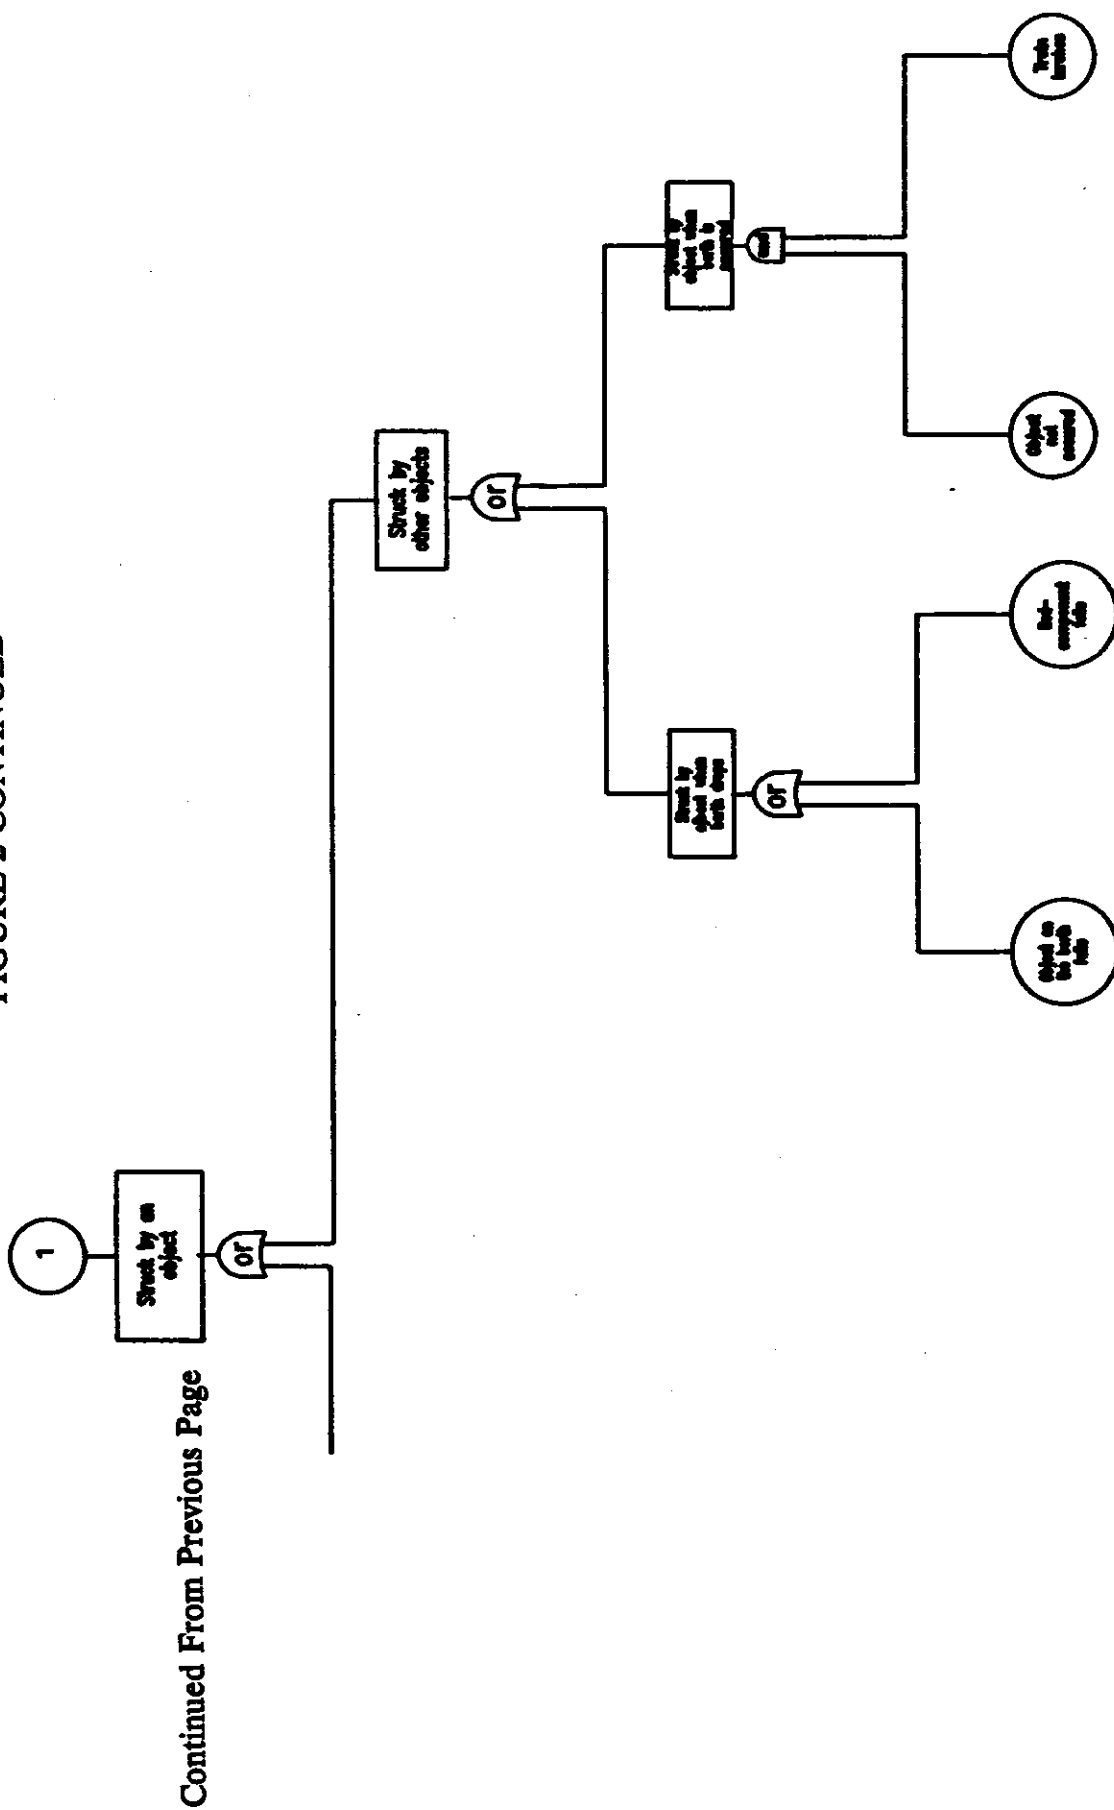
FIGURE 2 CONTINUED

The primary fault events for being **struck by an object** (Figure 2) are:

(1) unsecured nylon straps; (2) missing nylon straps; (3) bent ceiling hooks; (4) strap latch defect; (5) defective outboard scissor mechanism; (6) loss of balance; (7) broken hinges; (8) failure of release latch; (9) faulty outboard latching system; (10) object on bed falls when bed falls; (11) object on bed not secured; and (12) sudden movement of train. The primary fault events for **overexertion** (Figure 3) injury in the bedrooms are: (1) bed too heavy; (2) defective bed components; (3) defective latch pole; (4) defective scissor mechanism; (5) inadequate training on how to operate the beds; (6) training guidelines not followed; (7) over-reaching to make beds; (8) transfer of bulky mattress; (9) inadequate working space; and (10) upper bed too high for attendant. The primary fault events for **fall from elevation** (Figure 4) are: (1) sudden movement of train; (2) failure of ladder; (3) carrying an object while climbing ladder; (4) health condition of train attendant; (5) slippery ladder;

1. Maintenance of sleeper cars should be improved so that employees are not required to use malfunctioning equipment while the train is in-service. Train attendants should not be asked to perform maintenance duties outside of their normal duties on equipment which is in disrepair, as this is a potential source of injury.

3. Installation of the positive latch mechanisms in the deluxe bedroom upper beds should continue until they have been installed in the whole fleet of Superliner® sleeper cars. These positive latch mechanisms provide significant improvement in maintaining the beds in the upright position.

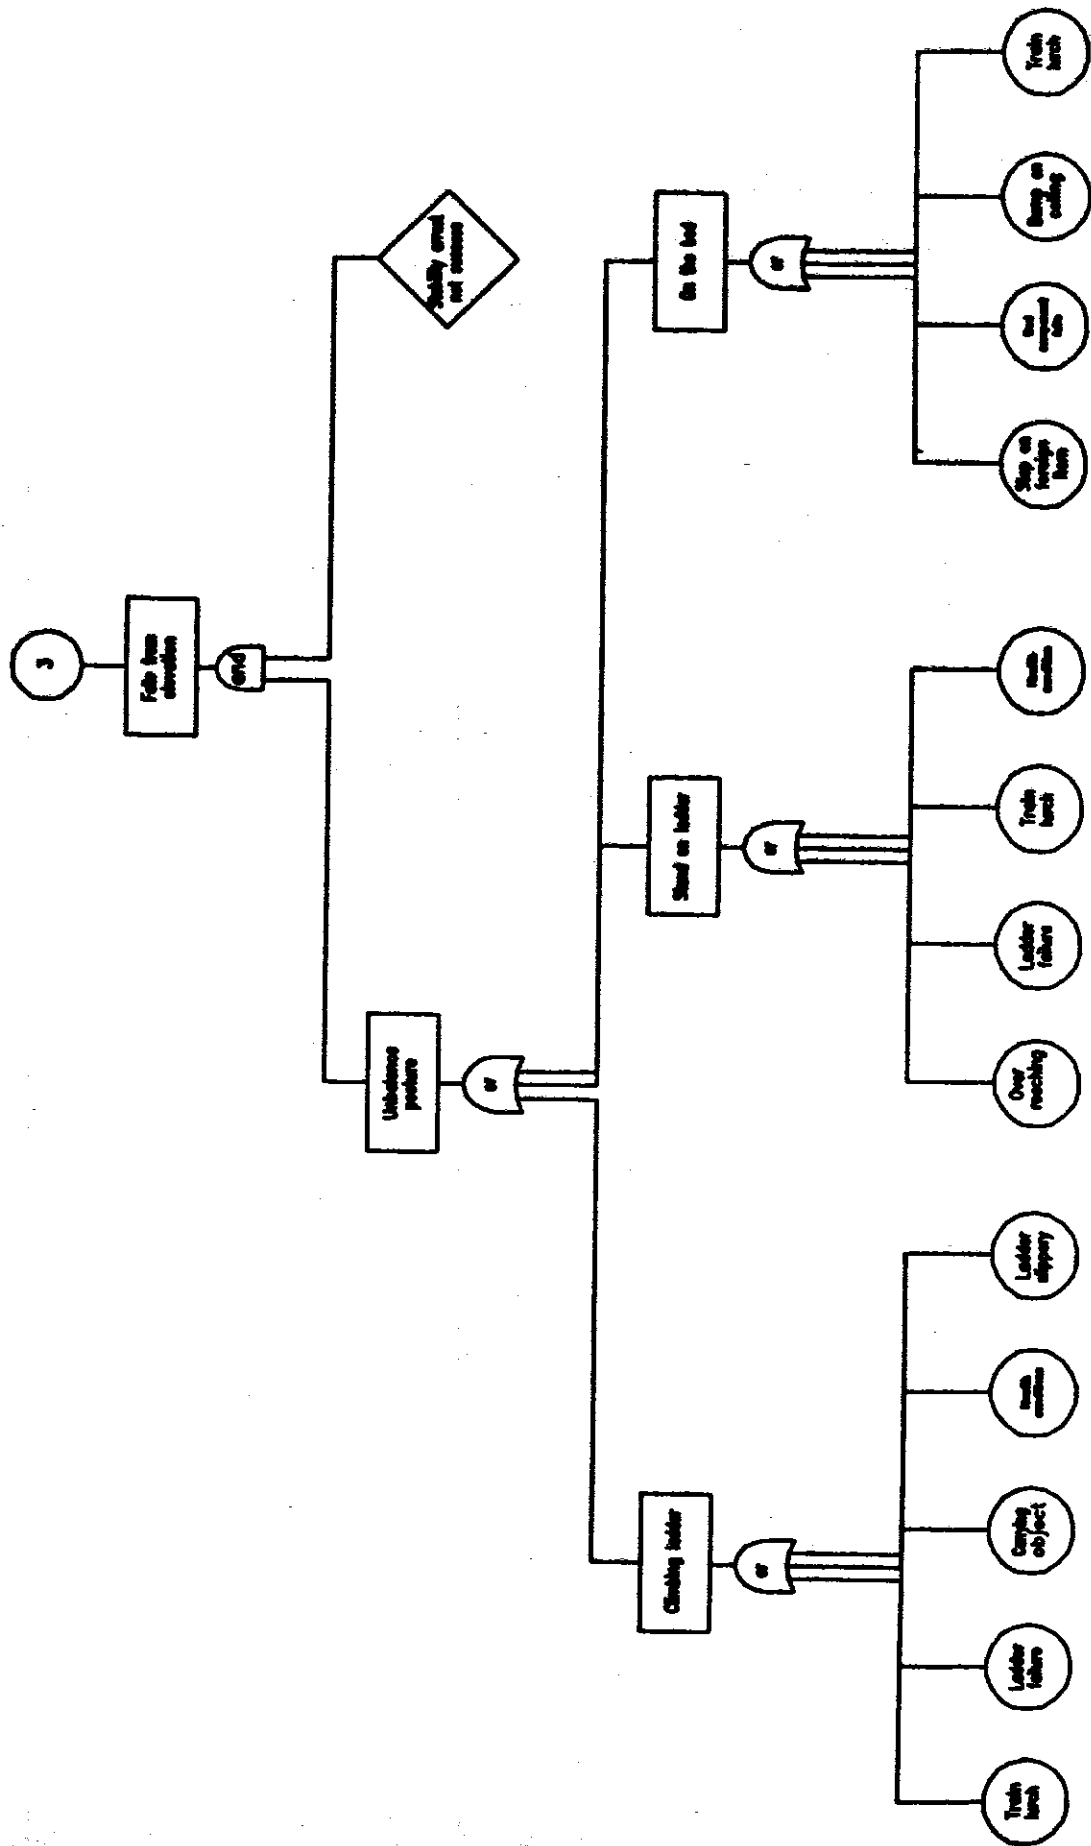
FIGURE 4 - Fault Tree Analysis for Fall from Elevation

(6) over-reaching while standing on a ladder; (7) stepping on foreign objects; (8) failure of bed component(s) when attendant is on the bed; and (9) attendant bumps ceiling when on the bed.

4. Overexertion control approaches should be developed and implemented. A foot stand is suggested for attendants to reduce/prevent the overexertion injuries during bed-making. Attendants should also be advised not to use the adjacent sink as a stand during bed-making because of the potential for tripping and falling.

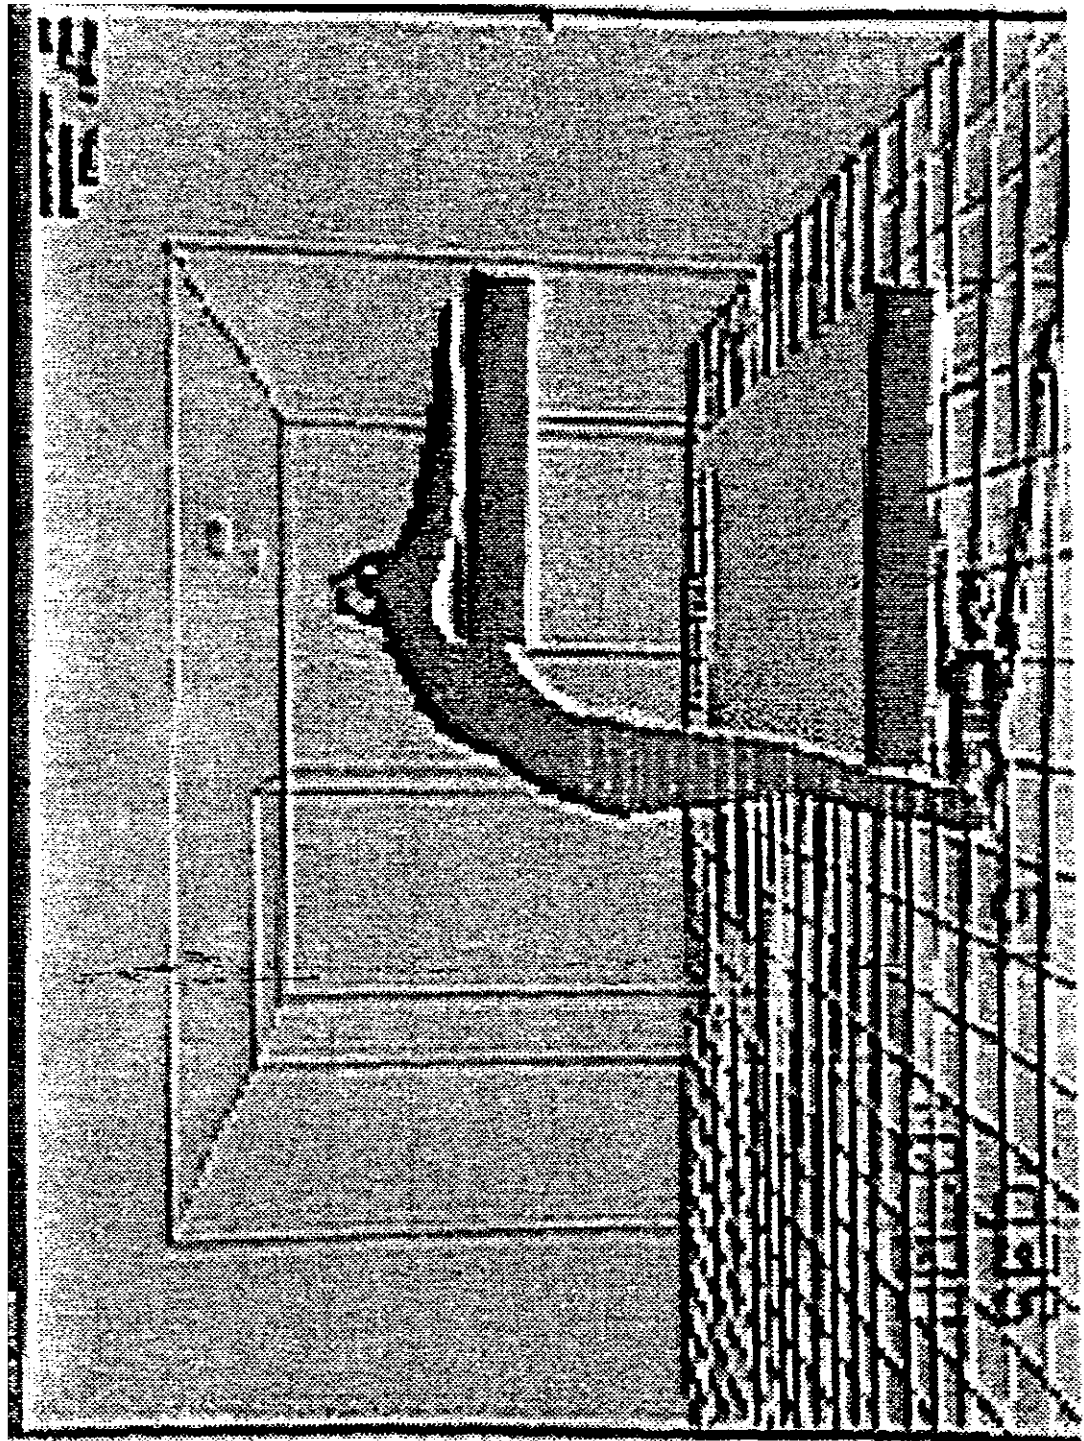
**FIGURE 5 - Functional Reach Simulation For Bed-Making
95th Percentile Female**

The results of the computer simulation indicate that most attendants have overexertion exposure potential in setting the upper beds. More than 95% of females and 50% of males will be over-stressed in making the beds when they stand on the floor (two functional reach diagrams are shown in Figures 5 and 6). Approximately 90% of females and 50% of males will not be able to hook or unhook the nylon straps from the ceiling without risk of overexertion.
